**UNITED STATES AIR FORCE  
JOINT BASE ELMENDORF-RICHARDSON,  
ALASKA**

*ENVIRONMENTAL RESTORATION PROGRAM*

**FOURTH CERCLA FIVE-YEAR REVIEW  
REPORT**

**JBER-ELMENDORF, ALASKA**

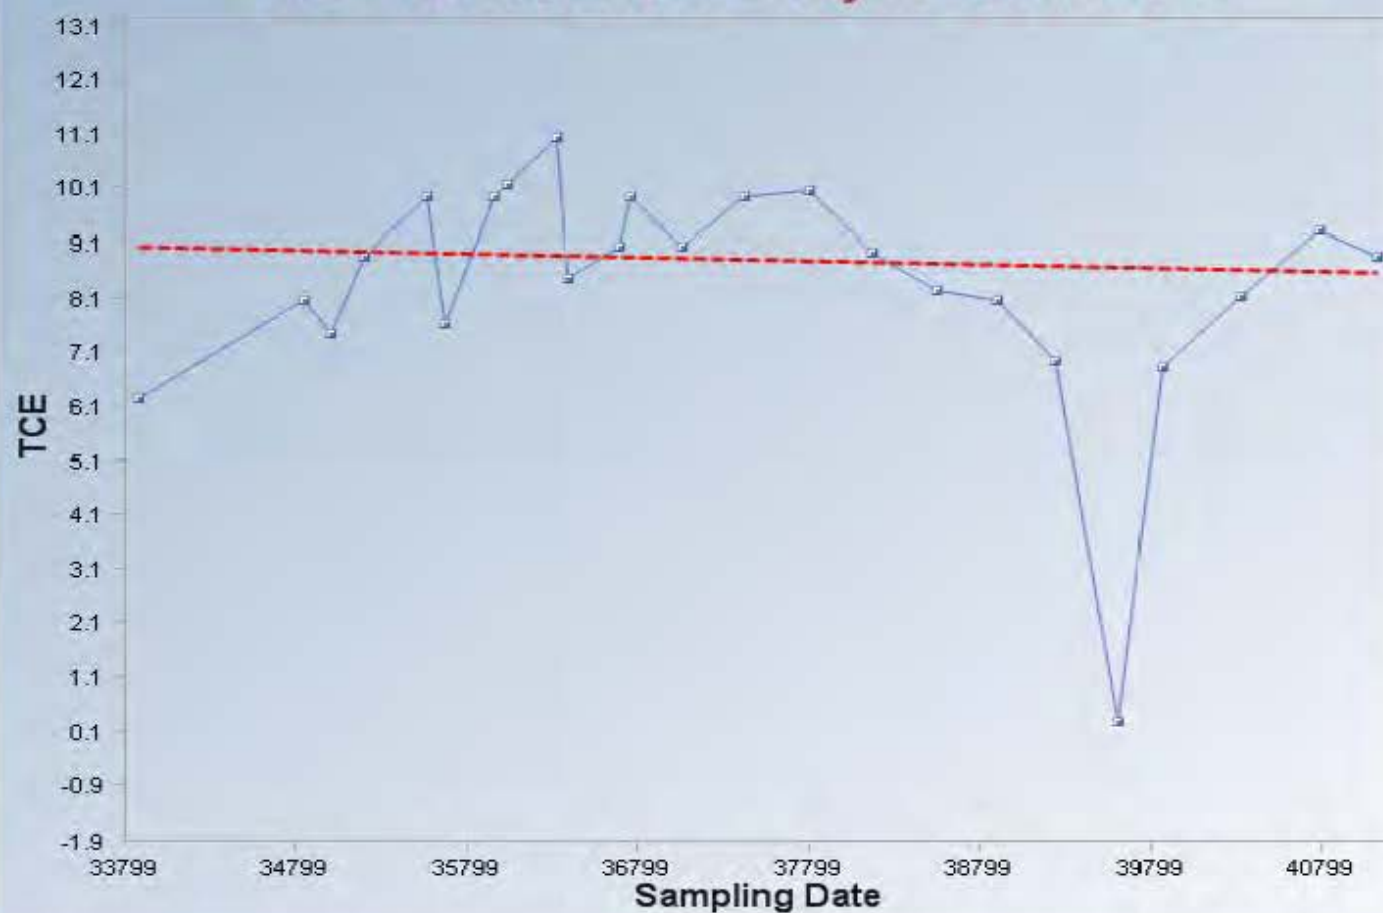
## Mann-Kendall Trend Analysis - LF59MW-03

n	24.0000
Confidence Coefficient	0.9500
Level of Significance	0.0500
Test Value (S)	-19
Critical Value (0.05)	-1.6449
Standard Deviation of S	40.1705
Standardized Value of S	-0.4481
Approximate p-value	0.3270

Insufficient evidence to identify a significant trend at the specified level of significance.

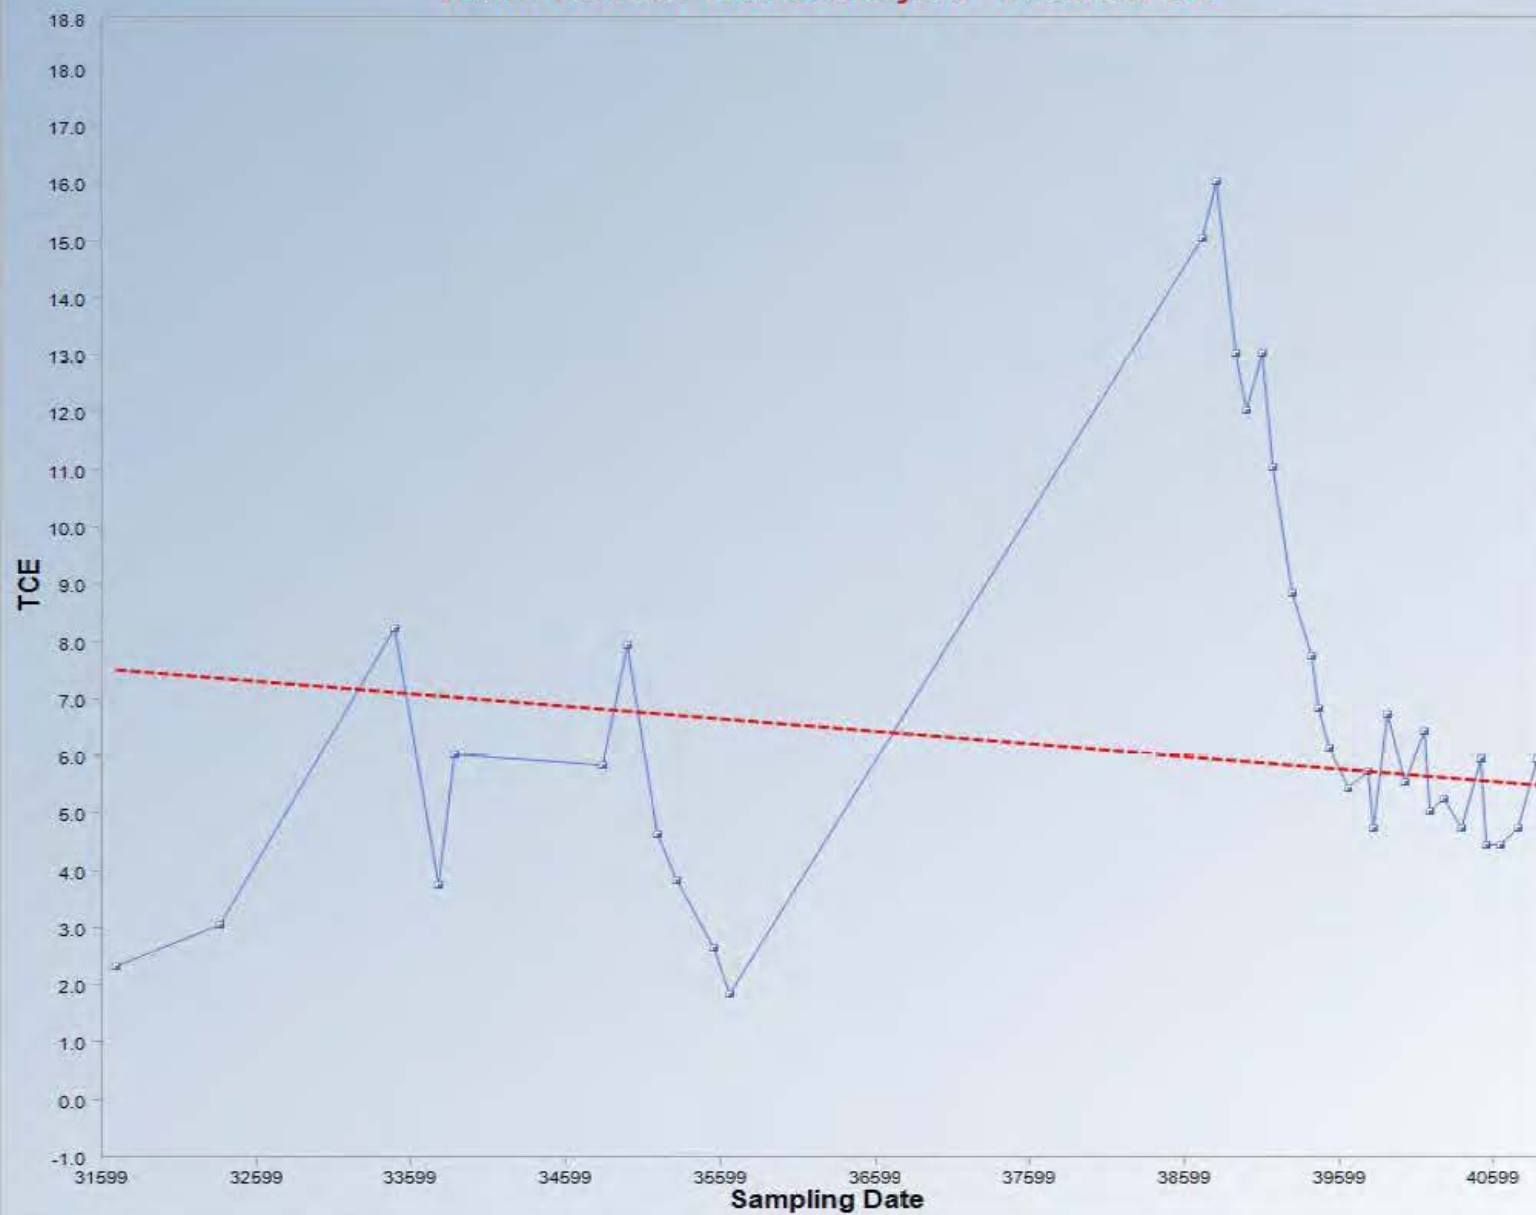
# Mann-Kendall Trend Analysis - LF05GW-2B

n	35.0000
Confidence Coefficient	0.9500
Level of Significance	0.0500
Test Value (S)	-59
Critical Value (0.05)	-1.6449
Standard Deviation of S	70.3681
Standardized Value of S	-0.8242
Approximate p-value	0.2049

Insufficient evidence to identify a significant

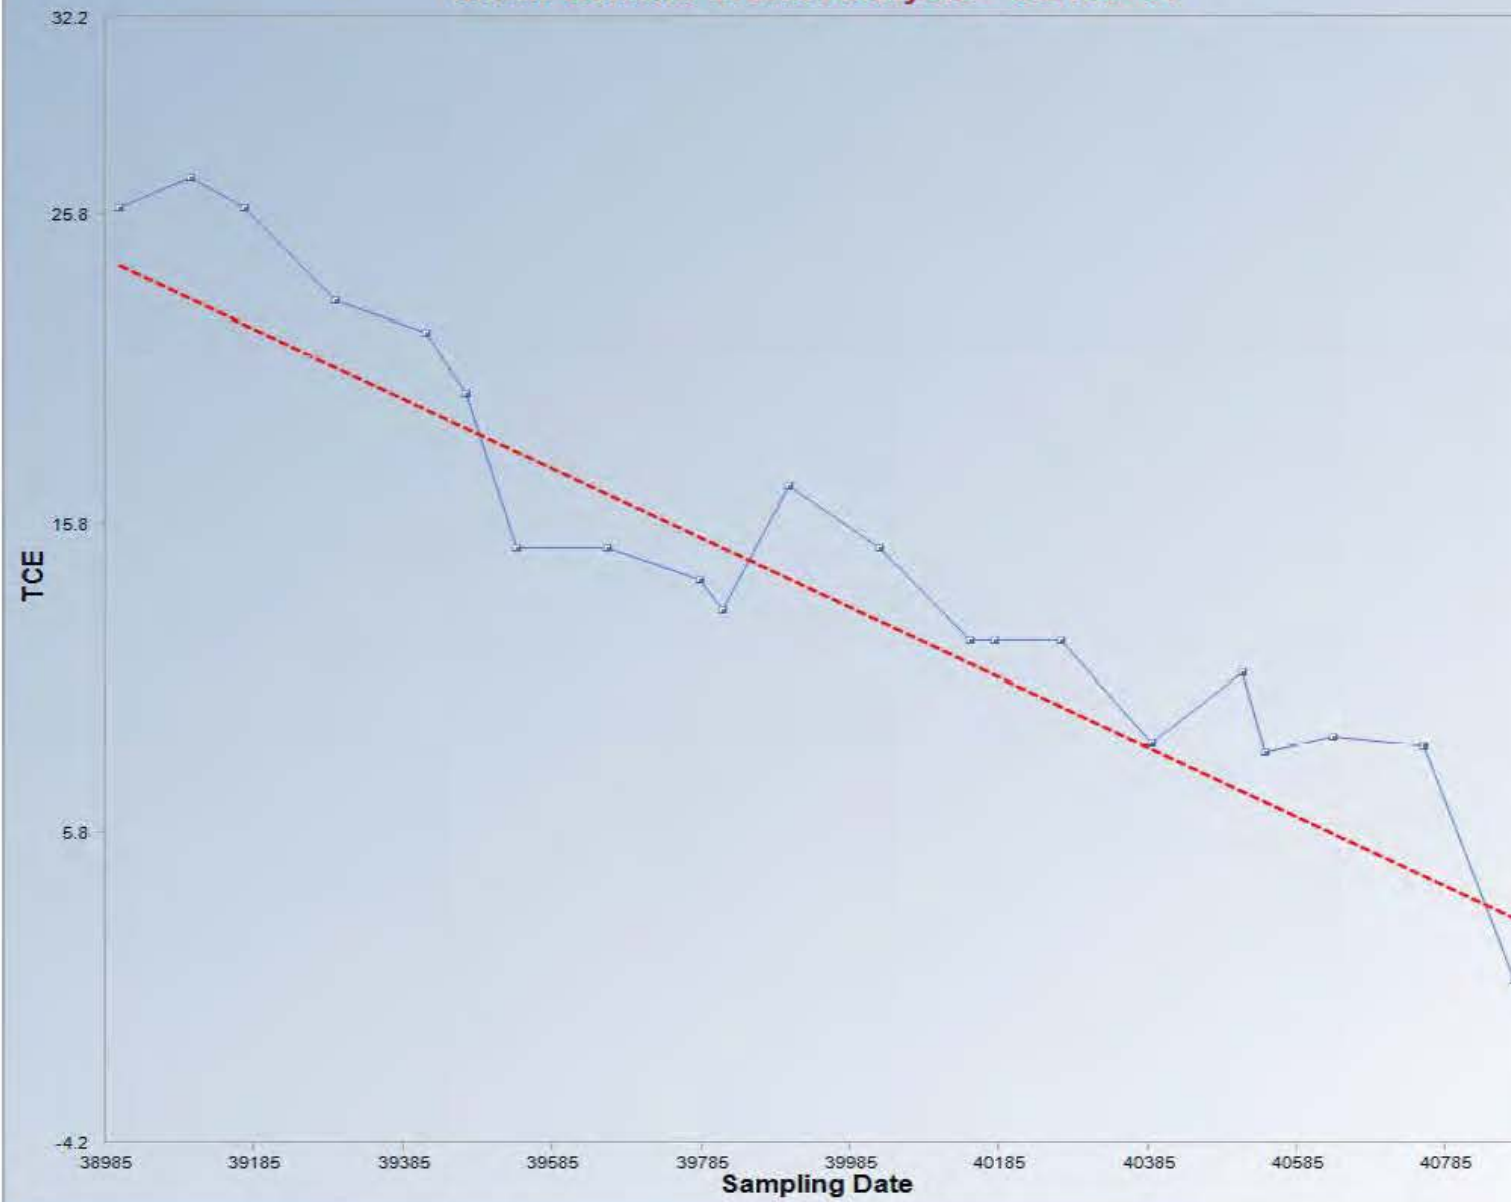
# Mann-Kendall Trend Analysis - OU1LF-19

n	21.0000
Confidence Coefficient	0.9500
Level of Significance	0.0500
Test Value (S)	-181
Tabulated p-value	0.0000
Standard Deviation of S	32.9899
Standardized Value of S	-5.4562
Approximate p-value	0.0000

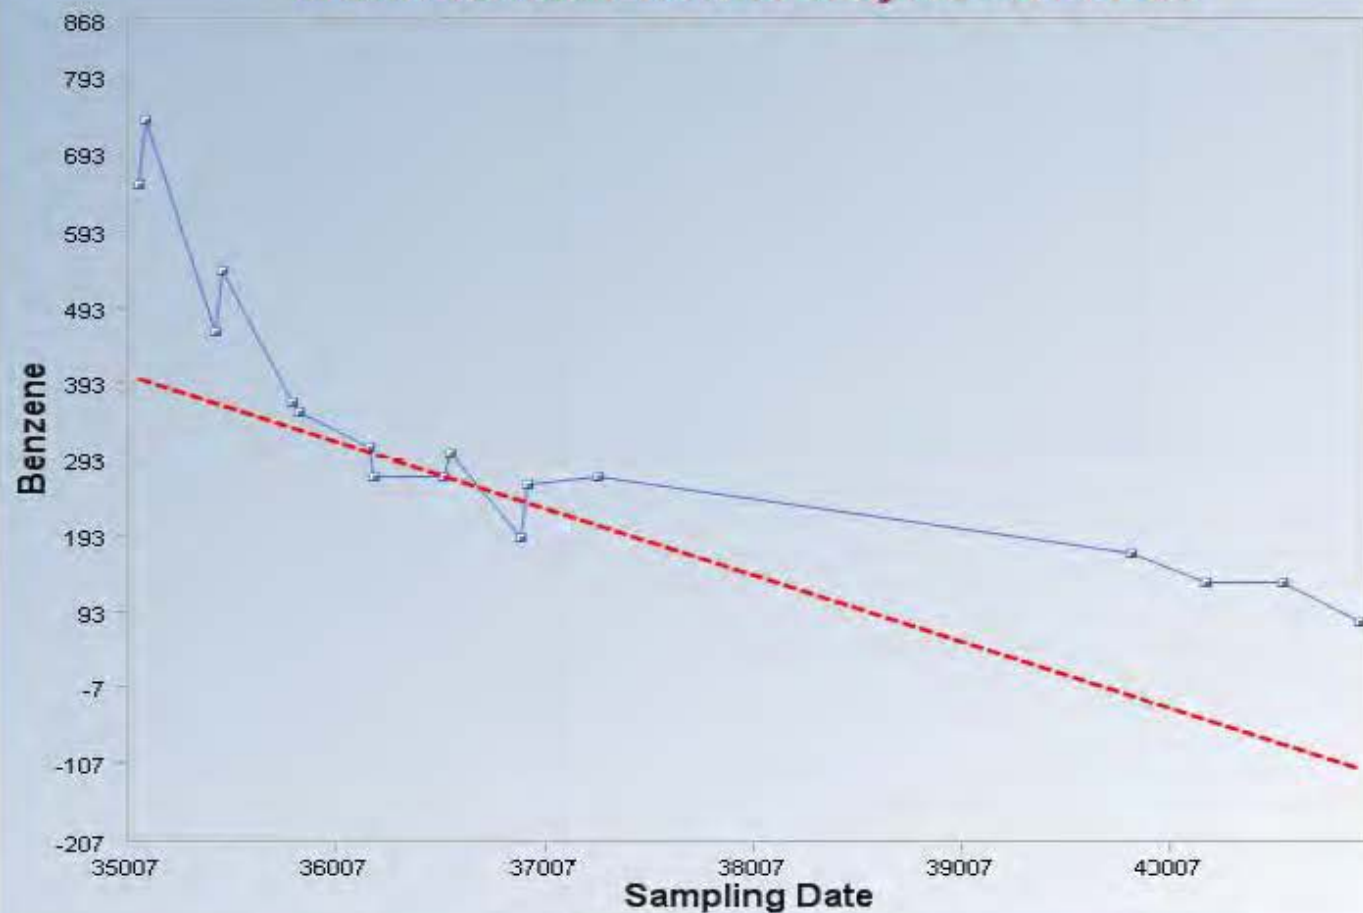
## Mann-Kendall Trend Analysis - ST41-28

n	17.0000
Confidence Coefficient	0.9500
Level of Significance	0.0500
Test Value (S)	-118
Tabulated p-value	0.0000
Standard Deviation of S	24.1799
Standardized Value of S	-4.8387
Approximate p-value	0.0000

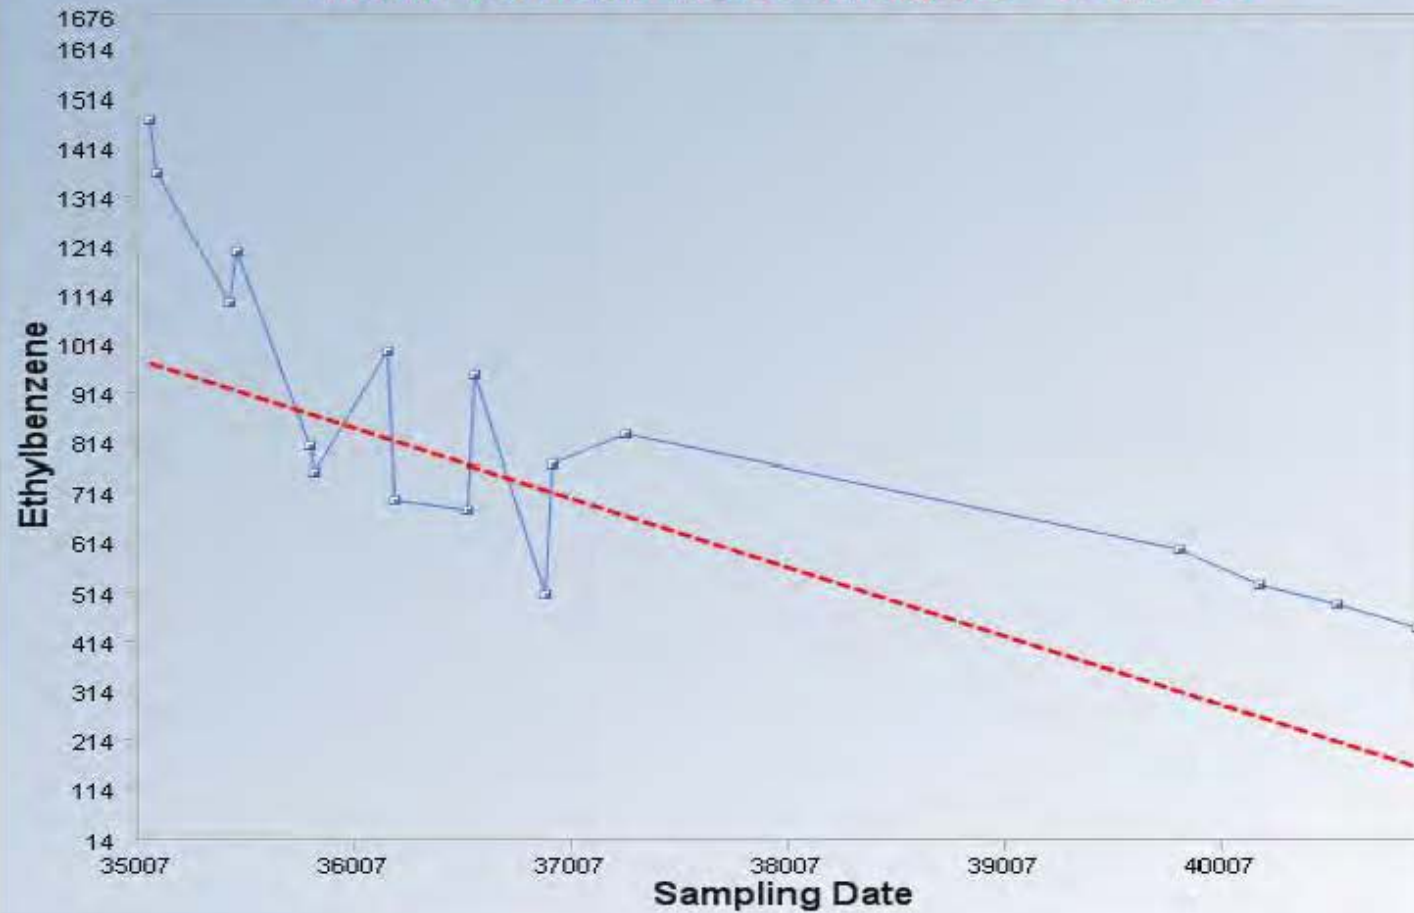
## Mann-Kendall Trend Analysis - ST41-28

n	17.0000
Confidence Coefficient	0.9500
Level of Significance	0.0500
Test Value (S)	-98
Tabulated p-value	0.0000
Standard Deviation of S	24.2762
Standardized Value of S	-3.9957
Approximate p-value	0.0000

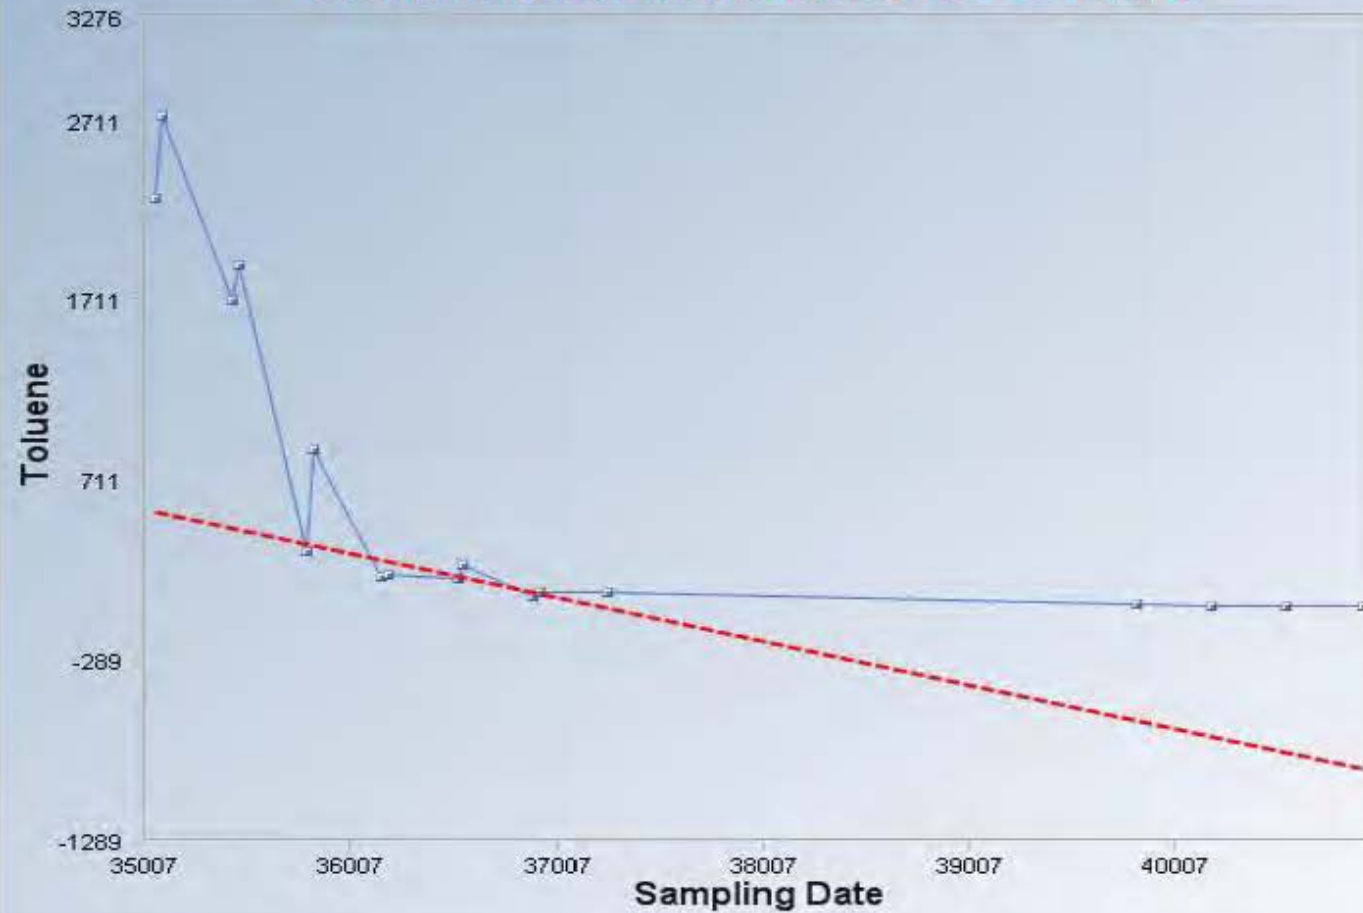
## Mann-Kendall Trend Analysis - ST41-28

n	17.0000
Confidence Coefficient	0.9500
Level of Significance	0.0500
Test Value (S)	-118
Tabulated p-value	0.0000
Standard Deviation of S	24.2762
Standardized Value of S	-4.8195
Approximate p-value	0.0000

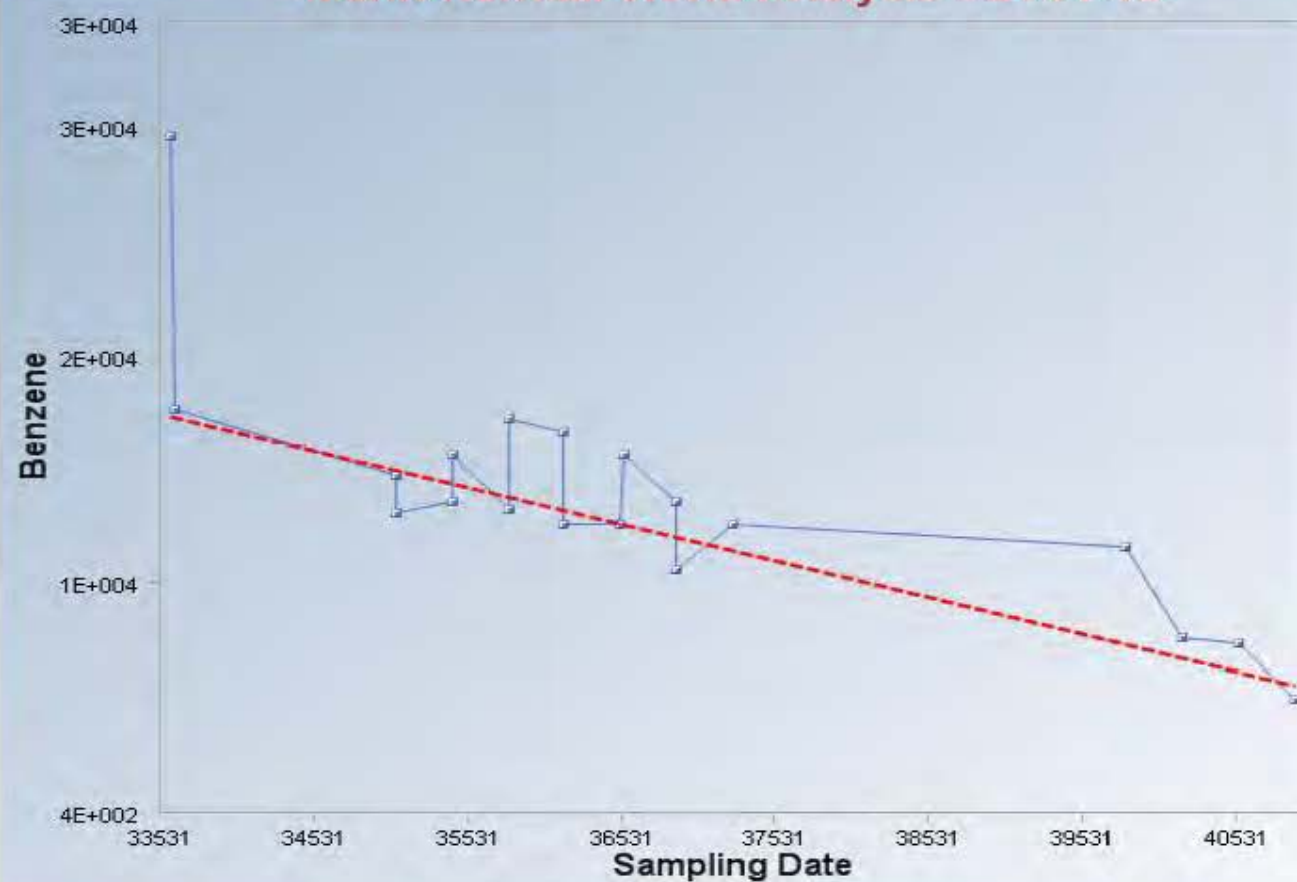
## Mann-Kendall Trend Analysis - ST41-16

n	19.0000
Confidence Coefficient	0.9500
Level of Significance	0.0500
Test Value (S)	-112
Tabulated p-value	0.0000
Standard Deviation of S	28.4839
Standardized Value of S	-3.8969
Approximate p-value	0.0000

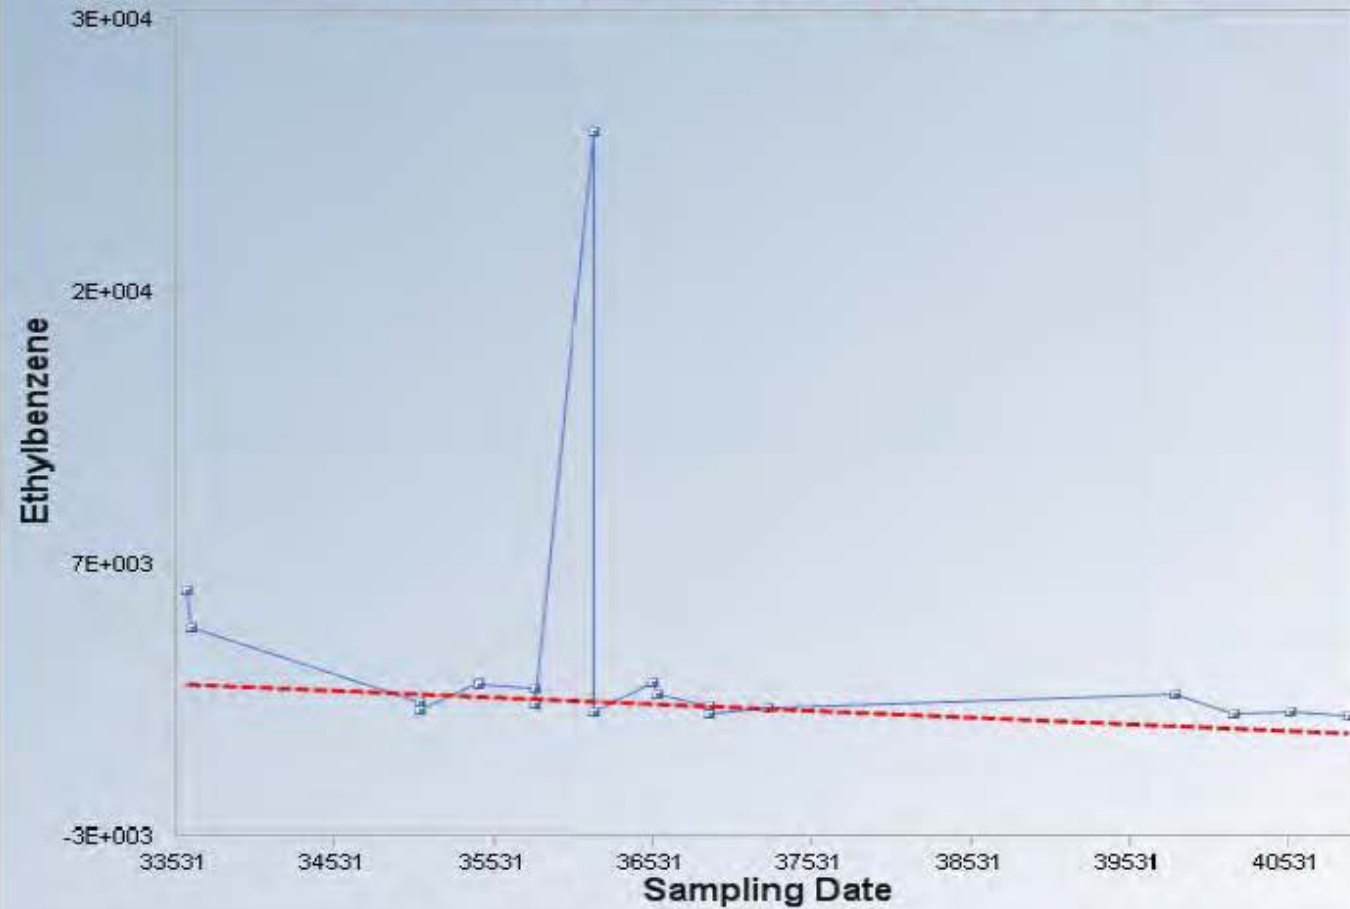
## Mann-Kendall Trend Analysis - ST41-16

n	19.0000
Confidence Coefficient	0.9500
Level of Significance	0.0500
Test Value (S)	-89
Tabulated p-value	0.0010
Standard Deviation of S	28.5132
Standardized Value of S	-3.0863
Approximate p-value	0.0010

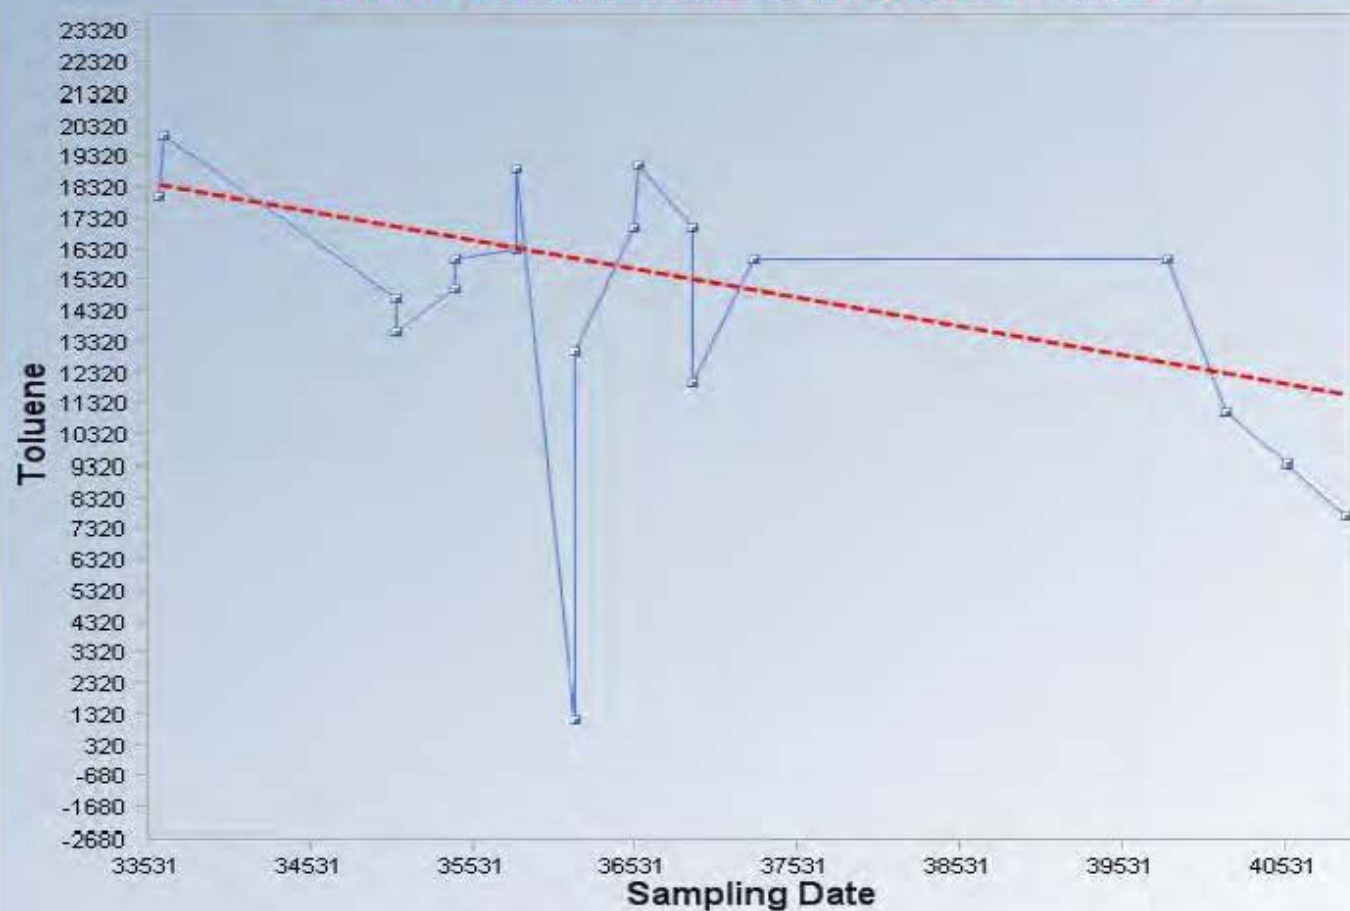
## Mann-Kendall Trend Analysis - ST41-16

n	19.0000
Confidence Coefficient	0.9500
Level of Significance	0.0500
Test Value (S)	-53
Tabulated p-value	0.0340
Standard Deviation of S	28.5015
Standardized Value of S	-1.8245
Approximate p-value	0.0340

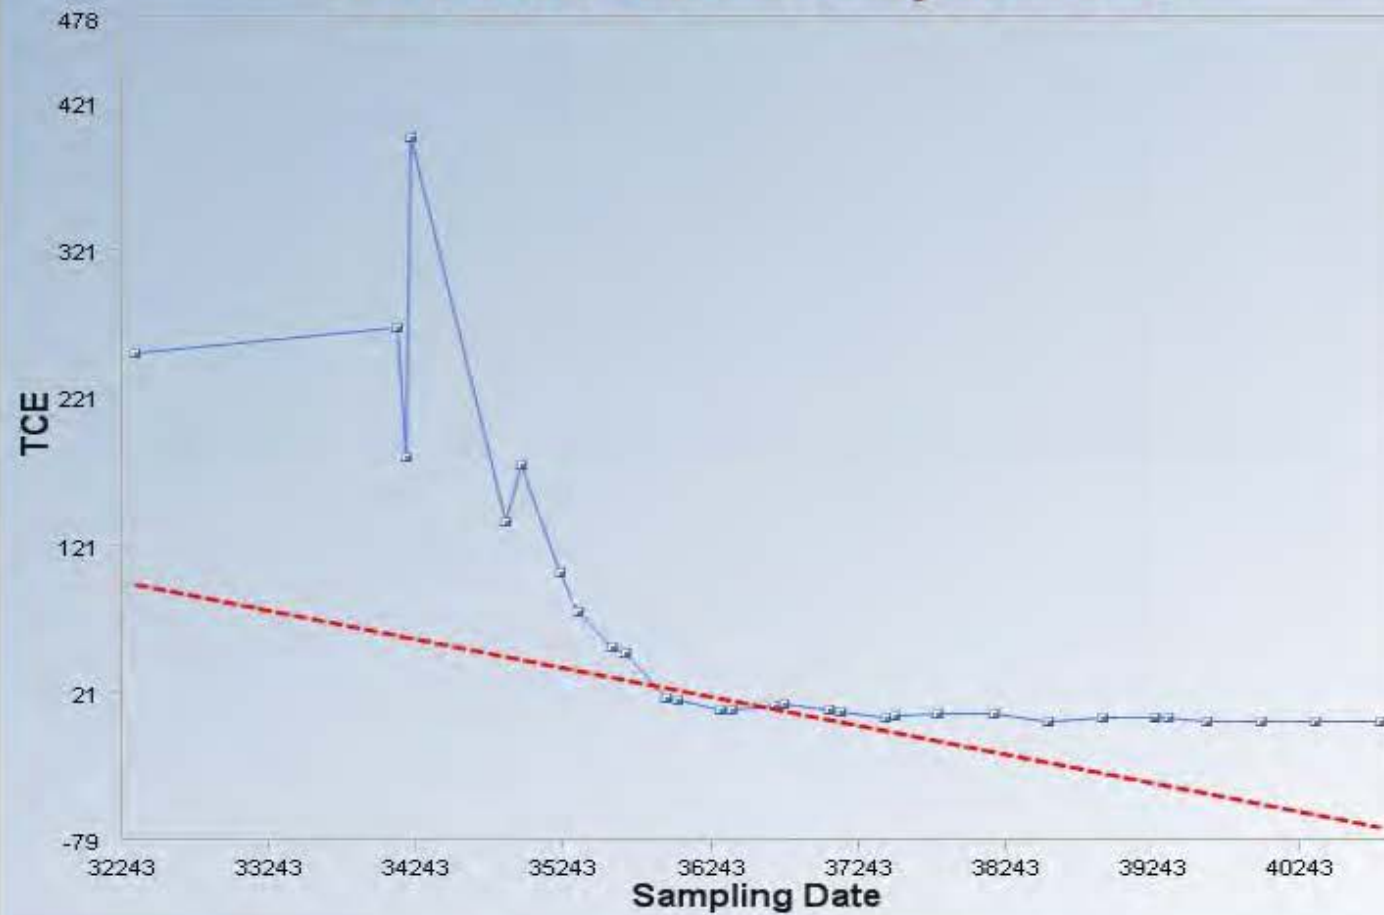
## Mann-Kendall Trend Analysis - FP-56

n	30.0000
Confidence Coefficient	0.9500
Level of Significance	0.0500
Test Value (S)	-386
Critical Value (0.05)	-1.6449
Standard Deviation of S	56.0417
Standardized Value of S	-6.8699
Approximate p-value	0.0000

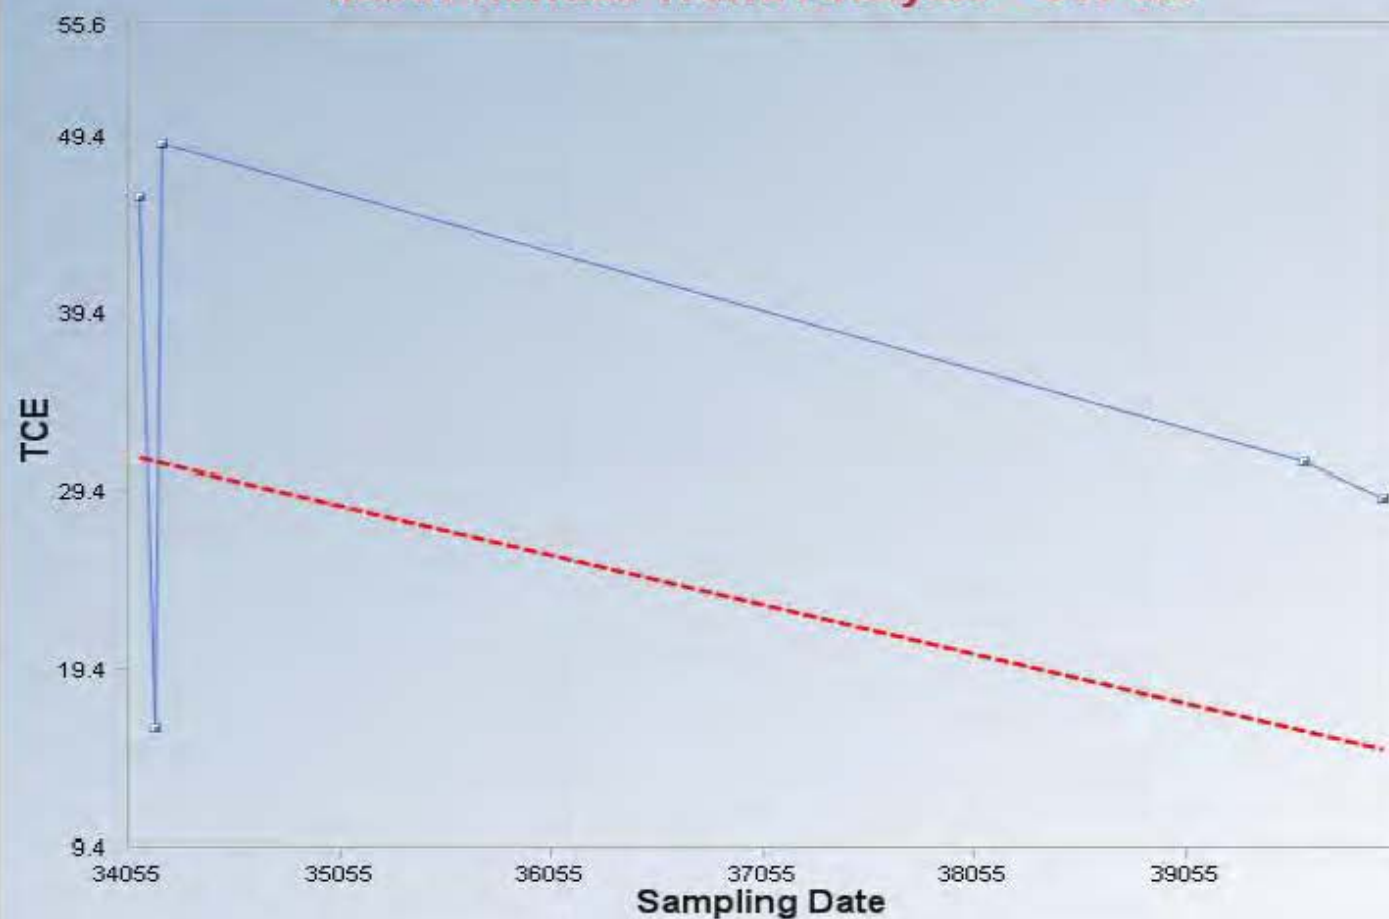
## Mann-Kendall Trend Analysis - GW-5A

n	5.0000
Confidence Coefficient	0.9500
Level of Significance	0.0500
Test Value (S)	-2
Tabulated p-value	0.4080
Standard Deviation of S	4.0825
Standardized Value of S	-0.2449
Approximate p-value	0.4032

Insufficient evidence to identify a significant trend at the specified level of significance.

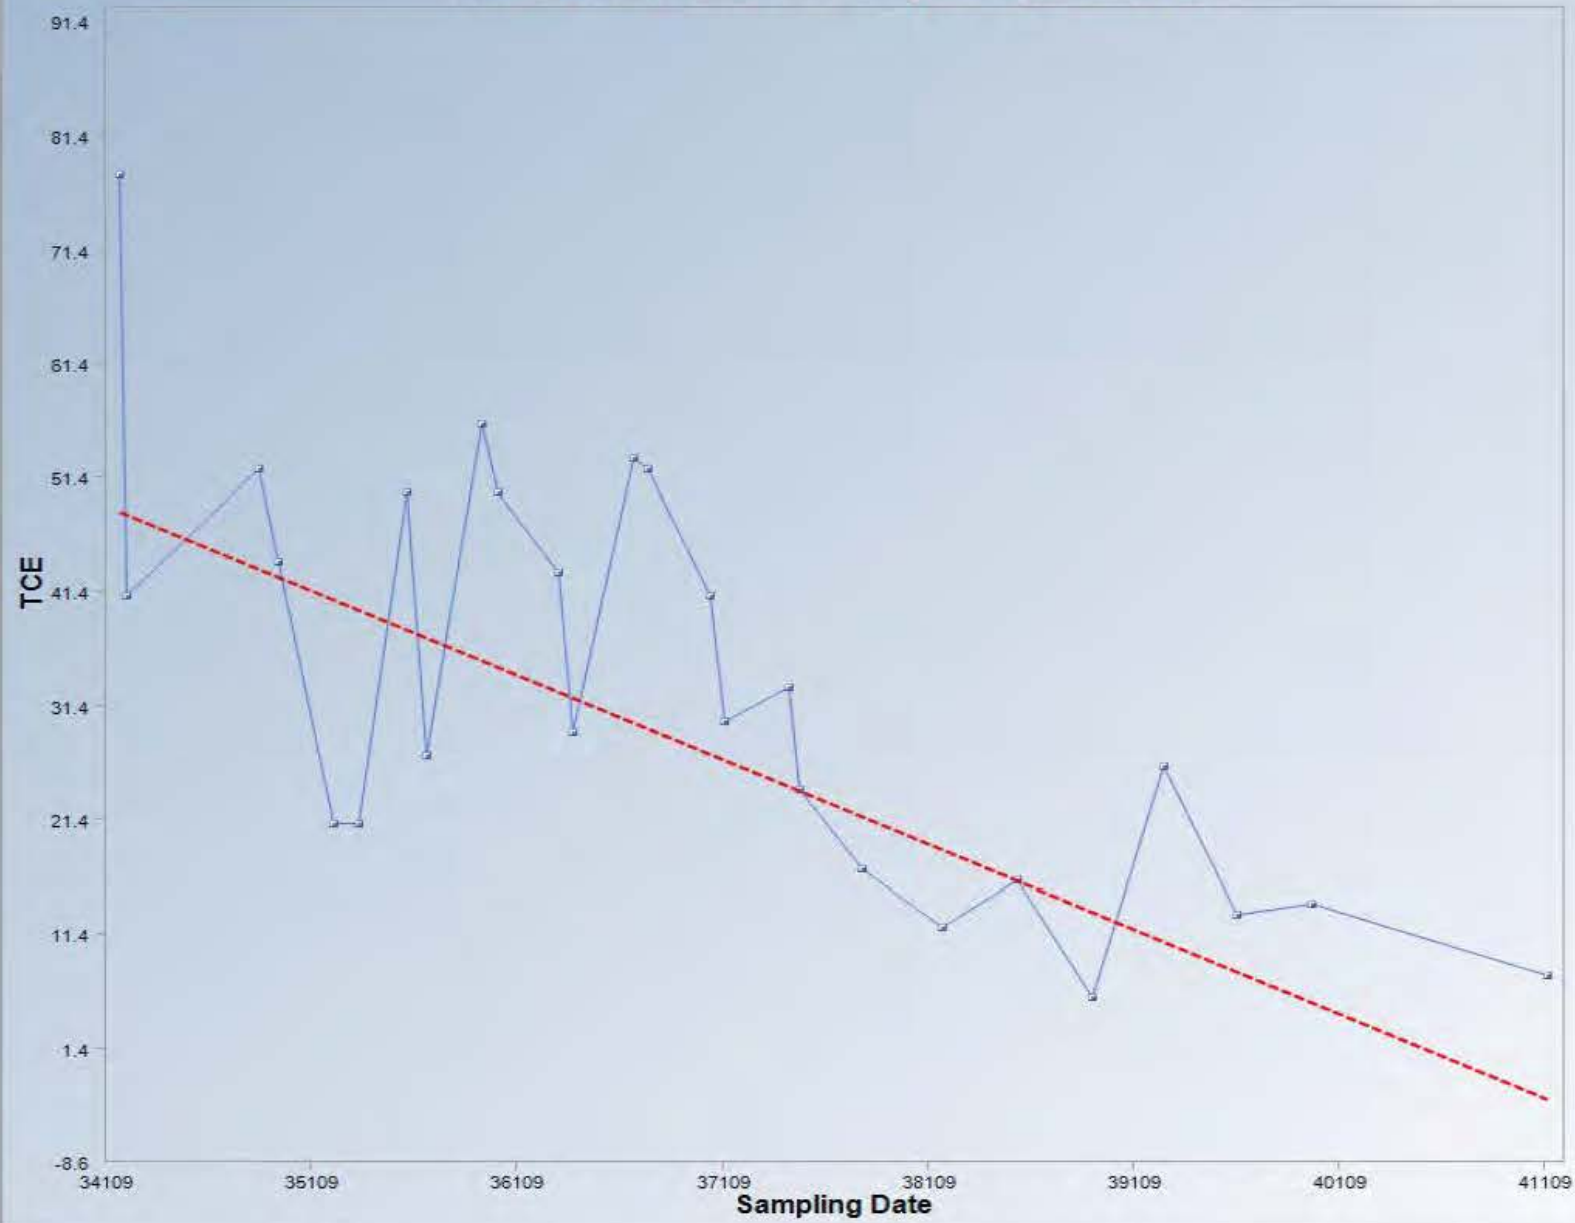
## Mann-Kendall Trend Analysis - OU4MW-11

n	26,0000
Confidence Coefficient	0.9500
Level of Significance	0.0500
Test Value (S)	-171
Critical Value (0.05)	-1.6449
Standard Deviation of S	45.3248
Standardized Value of S	-3.7507
Approximate p-value	0.0001

Statistically significant evidence of a decreasing trend at the specified level of significance.

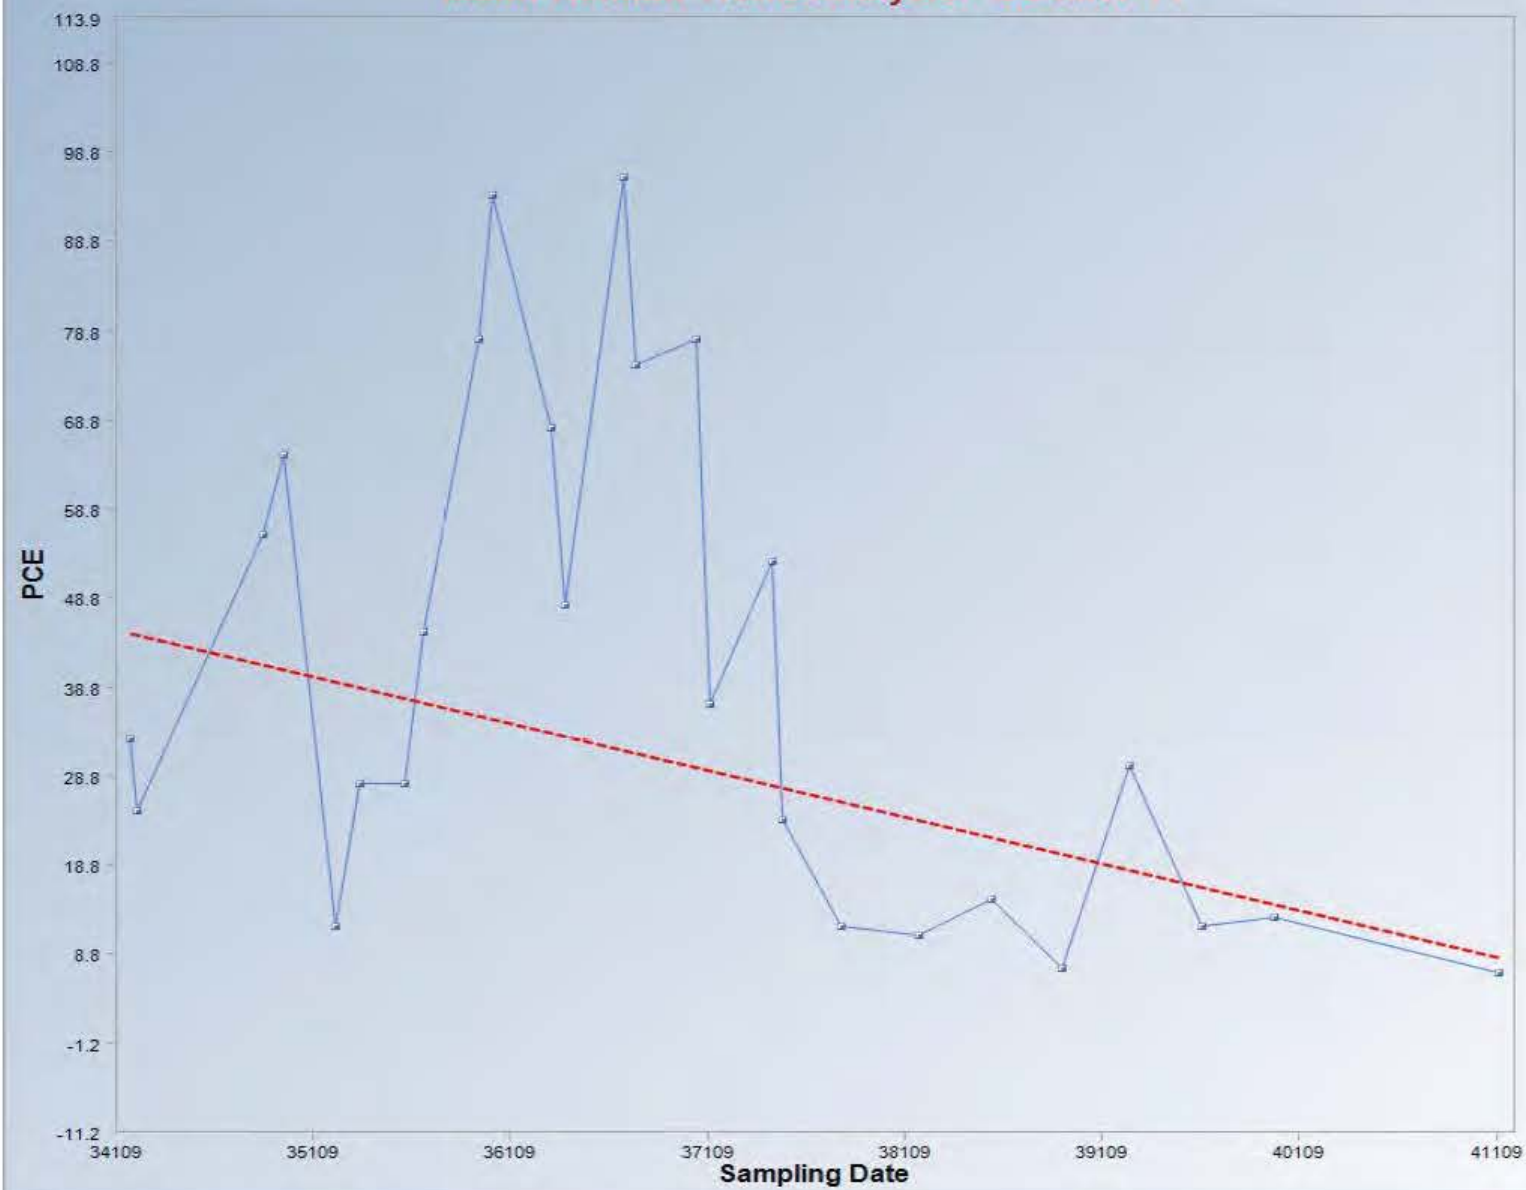
# Mann-Kendall Trend Analysis - OU4MW-11

n	26.0000
Confidence Coefficient	0.9500
Level of Significance	0.0500
Test Value (S)	-98
Critical Value (0.05)	-1.6449
Standard Deviation of S	45.3064
Standardized Value of S	-2.1410
Approximate p-value	0.0161

Statistically significant evidence of a decreasing trend at the specified level of significance.

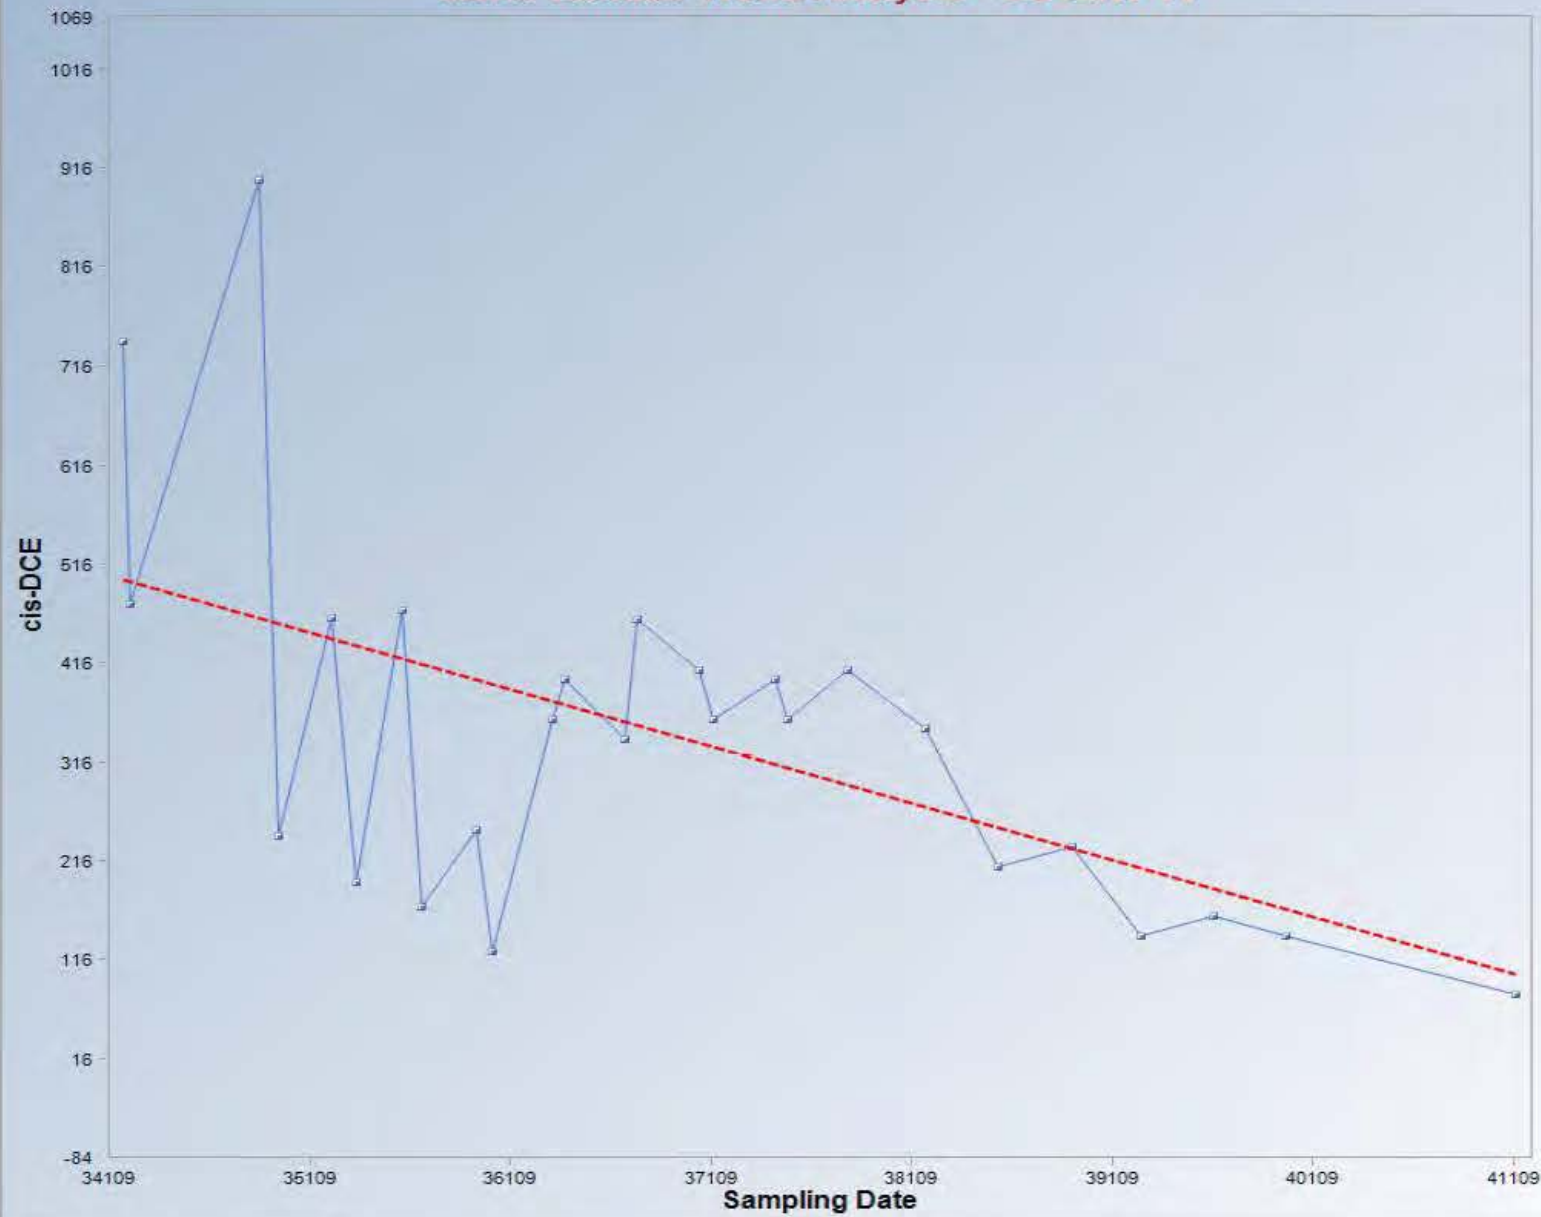
### Mann-Kendall Trend Analysis - OU4MW-11

n	26.0000
Confidence Coefficient	0.9500
Level of Significance	0.0500
Test Value (S)	-141
Critical Value (0.05)	-1.6449
Standard Deviation of S	45.2953
Standardized Value of S	-3.0908
Approximate p-value	0.0010

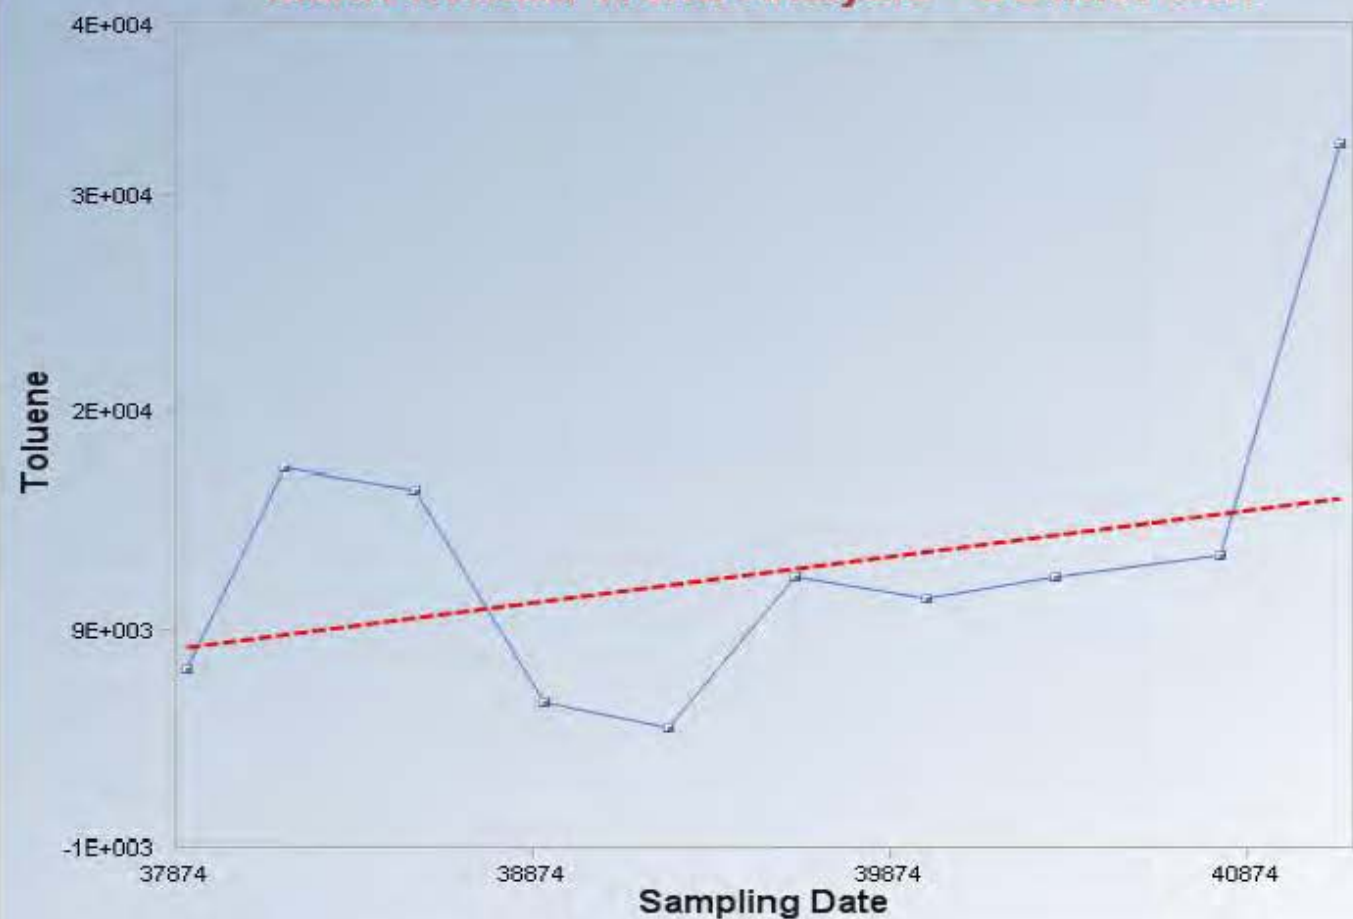
## Mann-Kendall Trend Analysis - OU4MW-08R

n	10.0000
Confidence Coefficient	0.9500
Level of Significance	0.0500
Test Value (S)	10
Tabulated p-value	0.1900
Standard Deviation of S	11.1355
Standardized Value of S	0.8082
Approximate p-value	0.2095
